Product Safety Recall July 05, 2003 SMB OPV

OMS announces recall of Surface Marker Buoys (SMB'S) and Lift Bags.

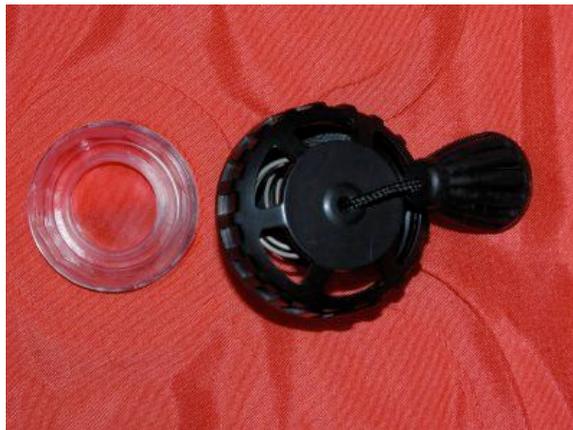
OMS LLC (OMS) of Middletown, NY, is recalling approximately (287) Surface Marker Buoys and (77) Lift Bags sold from March 03, 2003 to June 20, 2003 due to malfunctioning Overpressure (OPV) Valves. Molding variations in the male threaded component of the overpressure valve (OPV) used in both OMS Surface Marker buoys (SMB) and OMS Lift Bags, could cause the pull dump part (female threaded part) of the OPV to separate from the male threaded portion of the (OPV). This could cause deflation of the Surface Marker Buoy and lift bags.

It is very easy to determine what Surface Marker Buoys and Lift bags are suspect. Per the attached picture, the **malfunctioning** part is the male threaded part is **clear** in color and attached to the SMB or lift bag

Malfunctioning OPV If the male threaded part attached to your lift bag or SMB is **black** in color then it is **good** and is not affected!

Therefore, we are requiring that all affected Surface Marker Buoy's and Lift Bags (only those with **clear male threaded parts** per Photo "Malfunctioning OPV") be updated with new assemblies.

All affected OMS Surface Marker Buoys ([SMB's](#)) and Lift Bags that were sold by Authorized OMS dealers and OMS distributors from March 03, 2003, and are equipped with a CLEAR male threaded part (Picture "Malfunctioning OPV") are considered to be malfunctioning and must be returned to OMS.

Consumers should stop using these units and contact OMS immediately at: a. 845-457-1501 or by fax: 845-457-1504 . OMS will repair or replace your SMB or Lift Bag at no charge.
